Project: Casa Clara Condominium Assoc., Inc.
201 E. Ocean Drive
Key Colony Beach, FL 33051

Re: Milestone Damage Survey Report

Casa Clara Milestone Report Photograph Log

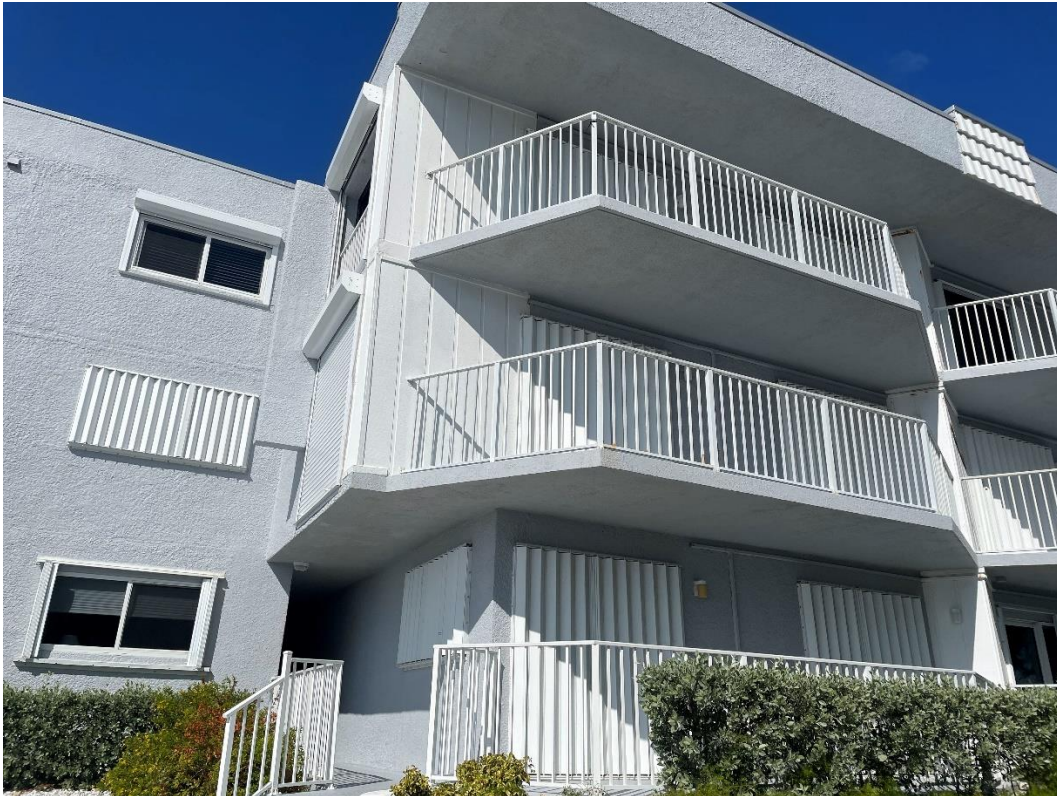
Photo #3 - Typical East and West Balconies at Buildings #1 and #3

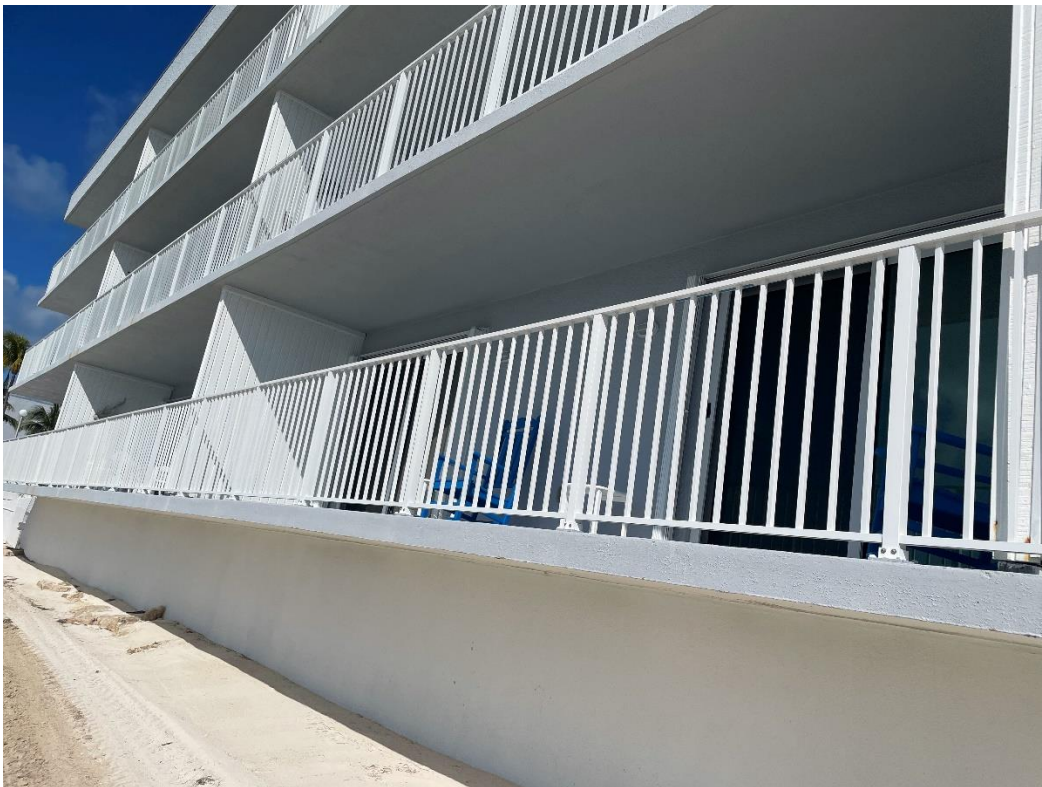
Photo #4 - Typical South Balconies at Buildings #1 and #3

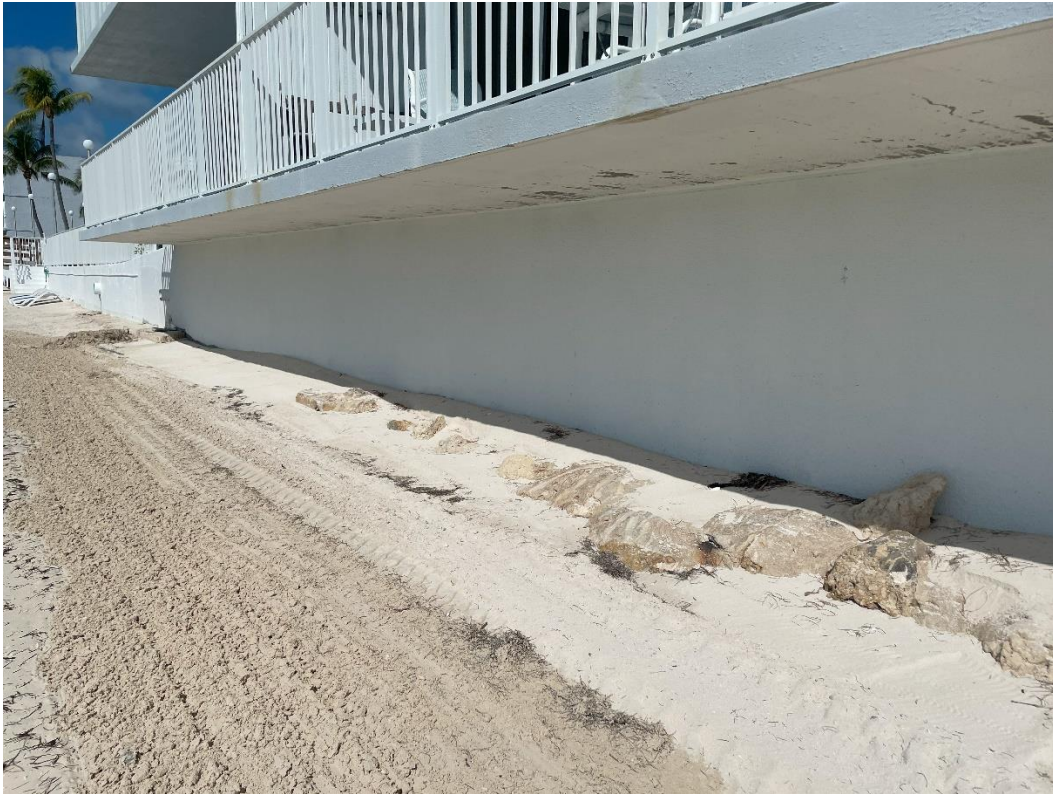
Photo #5 - Retaining Wall Below 1st Floor – Buildings #1 and #3

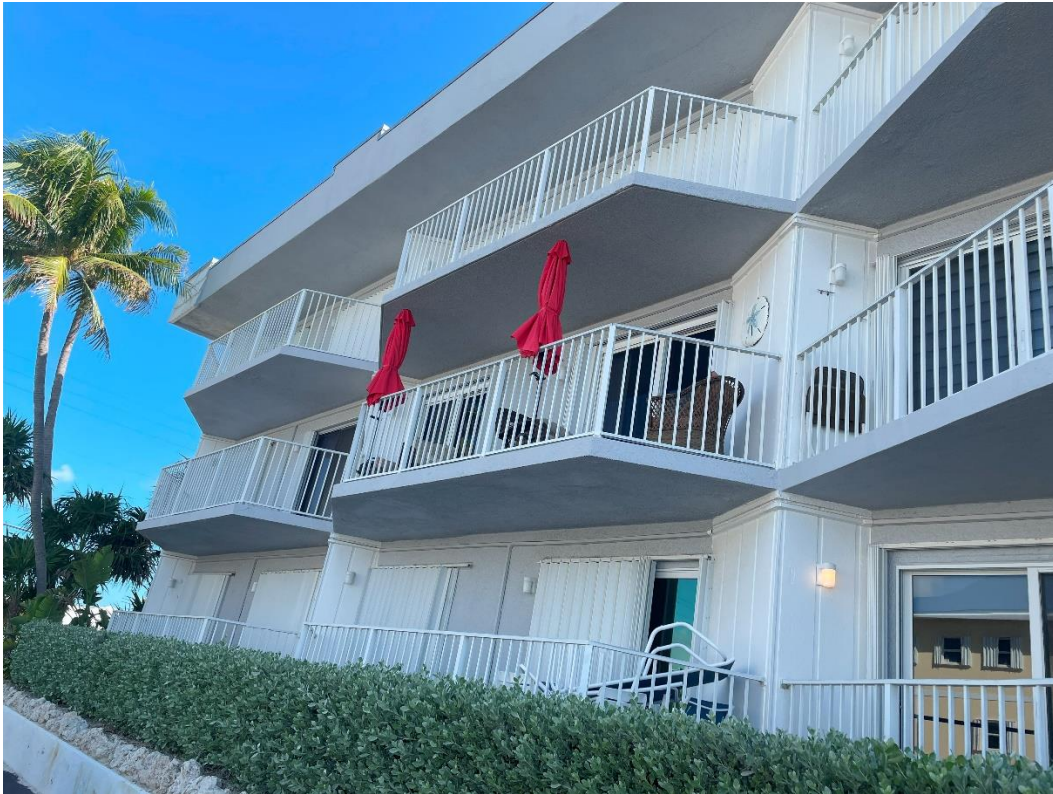
Photo #7 - Typical East and West Balconies at Buildings #1 and #3

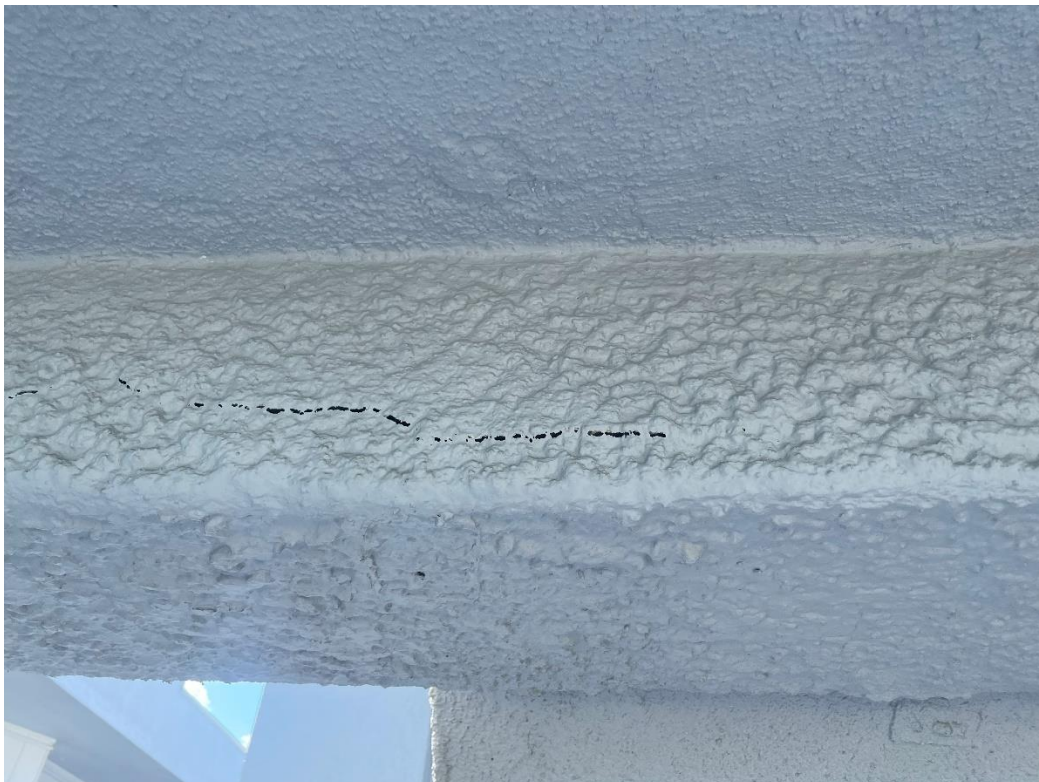
Photo #8 - Crack in Beam

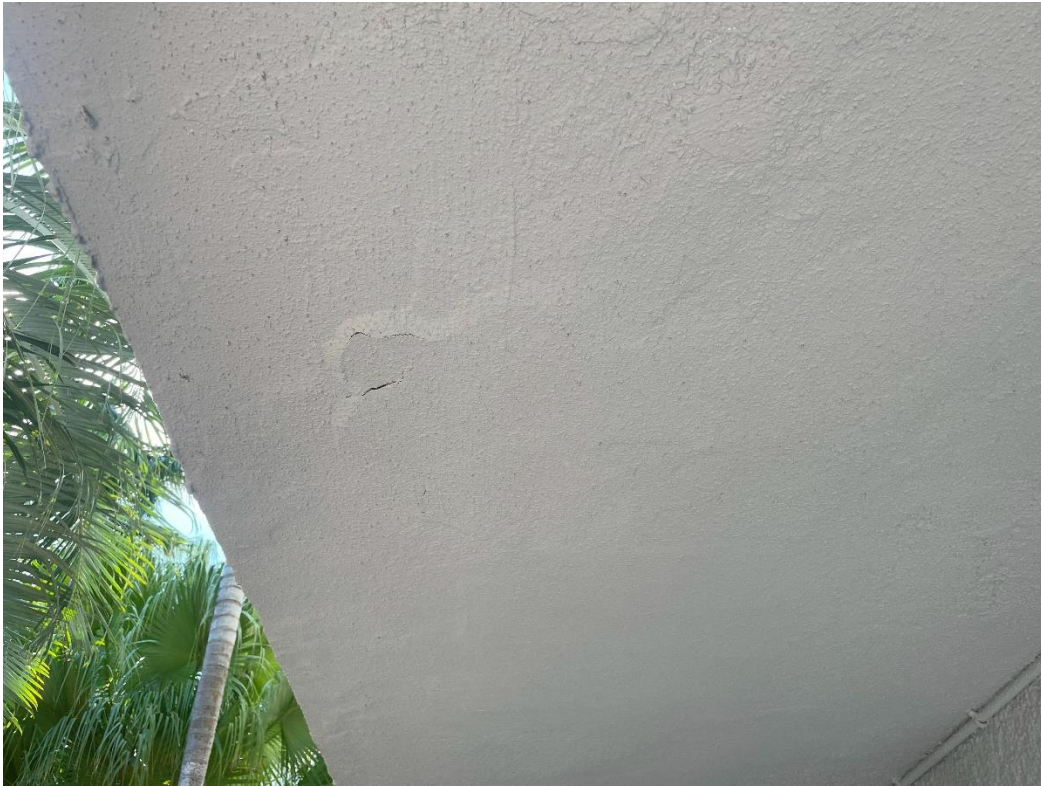
Photo #9 - Overhead Spall

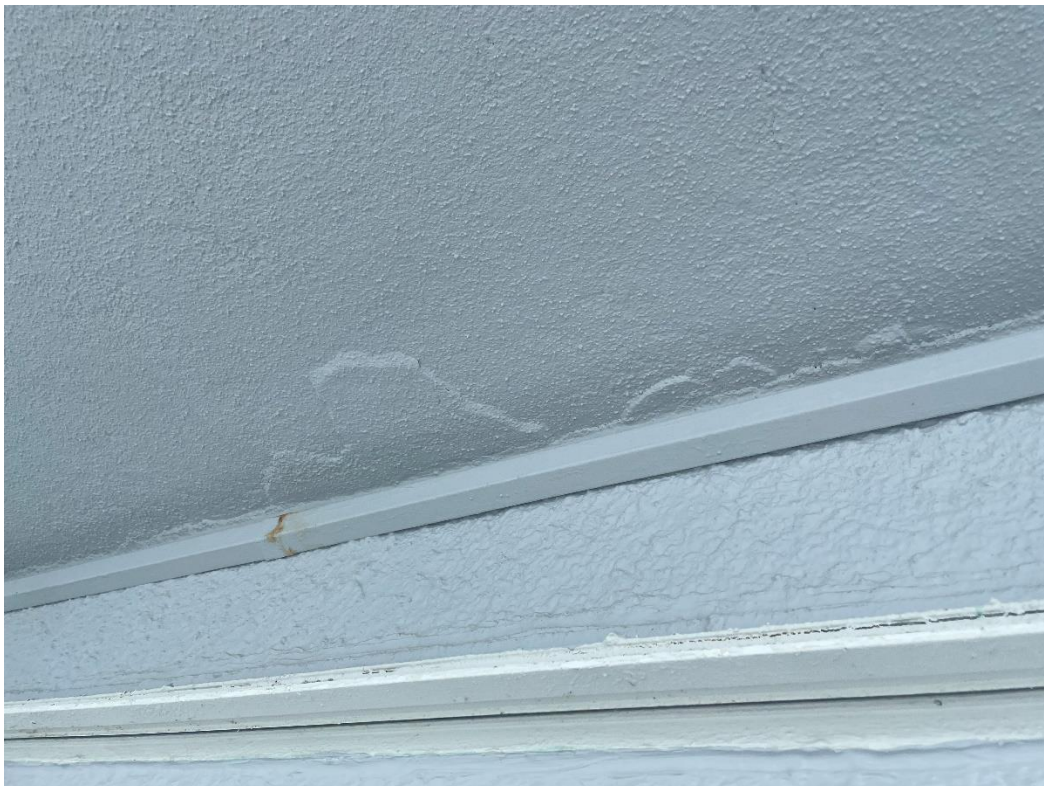
Photo #10 - Overhead Spall

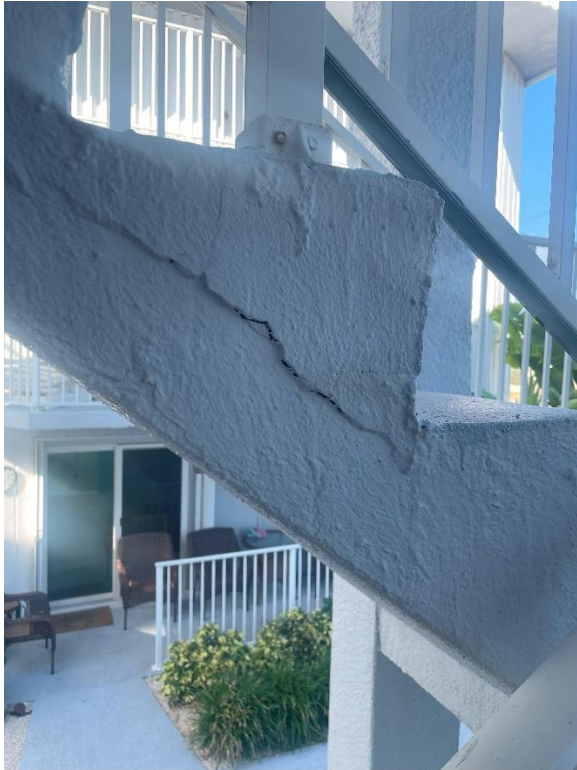
- The stairs are exposed to the elements, with the undersides and sides stucco-ed and painted and the treads and riser surfaces waterproofed. There are two sets for each building.
- Minor, isolated spalling was observed at a few stair locations.

Photo #11 - Spalled Stair Edge

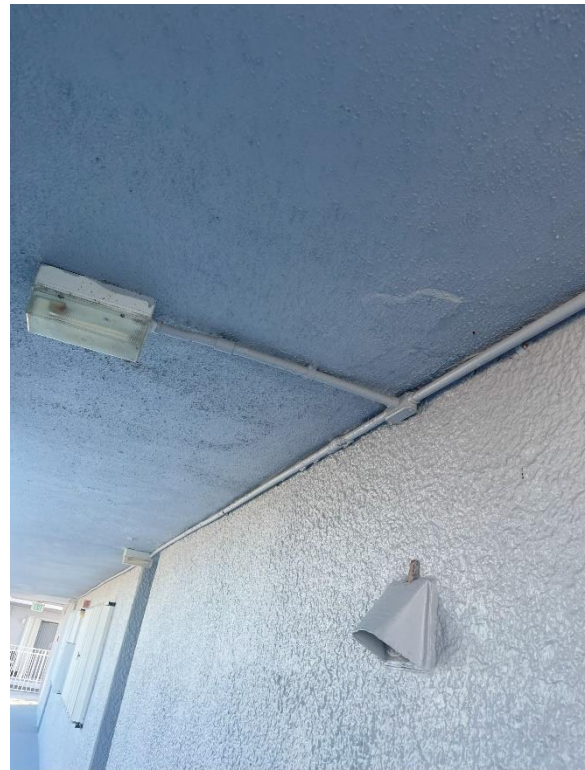
Photo #12 - Overhead Spall

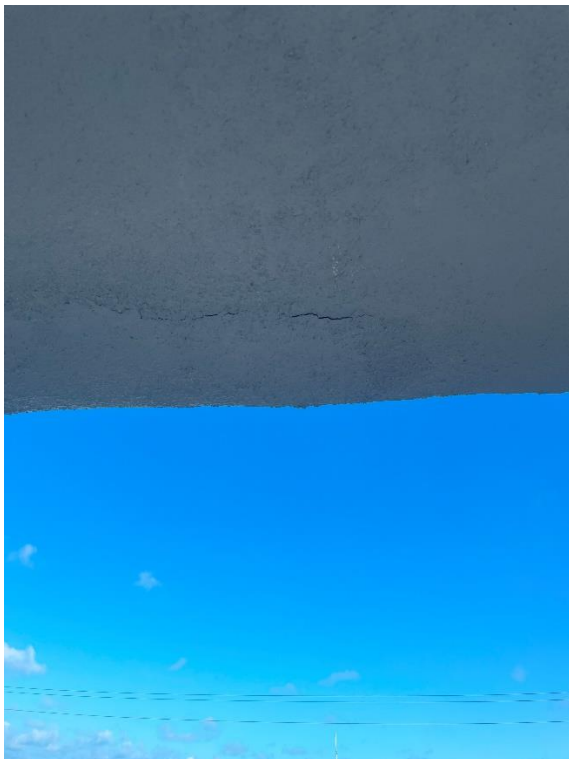
Photo #13 - Edge Spall

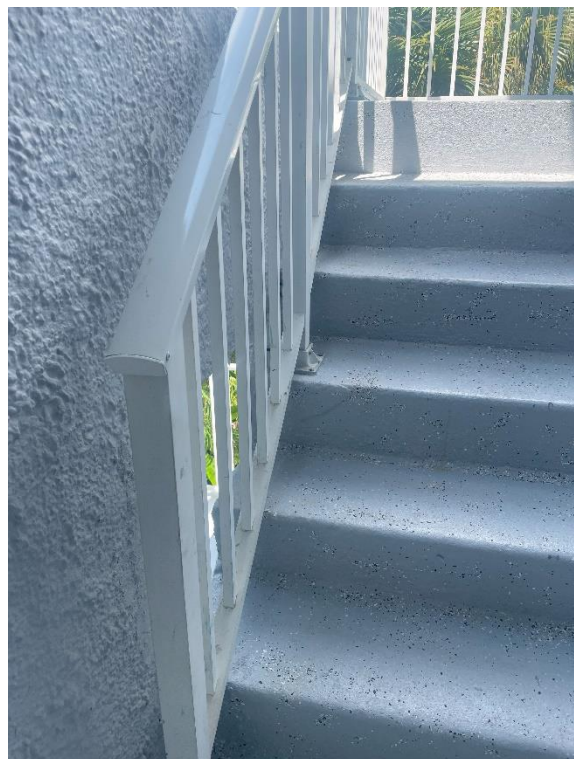
Photo #14 - Tread Spall at Stairs

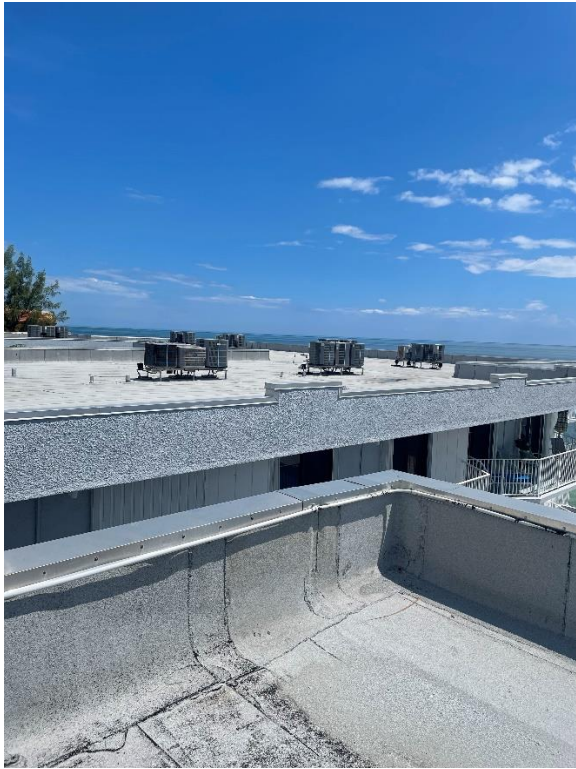
- The roofs on all three buildings have been replaced within the last five years and appear to be in good shape.

Photo #15 - Roof Corner w/ Parapet Wall Cap

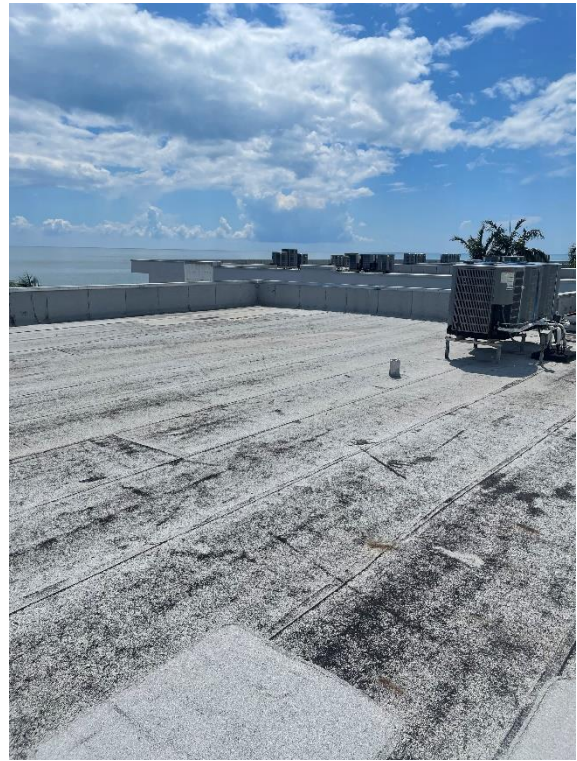
Photo #16 - Overview of Roof
